Manhole Inspection Summary

Manhole # S15Q__018MH

Insp Date: **12/8/08 12:33 PM**

Location Address: **2793 WILKENS AV**

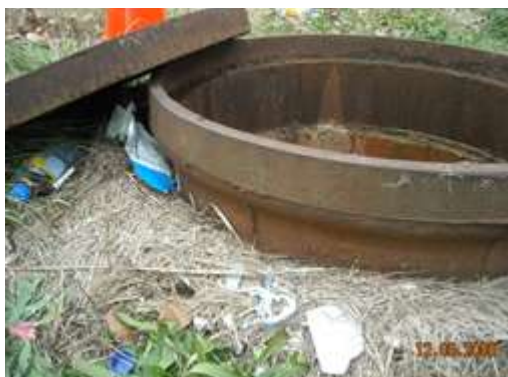
Miscellaneous

Cover Shape: **Circular** Diameter: **30** (in.) Length: **0** (in.) Dist A/B Grade: **10** (in.)

FRAME ABOVE GRADE

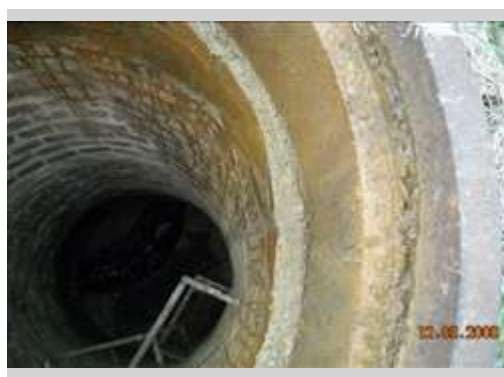
Defect 1

Frame Offset: **1** (in.) Condition: ☒ Sound ☐ Cracked ☐ Leaks

FRAME OFFSET

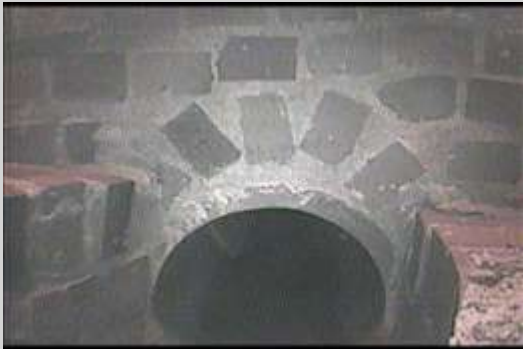
12 O'Clock Outflow

12 in. Circular Gravity Sewer
Pipe Out @ 12 O'Clock

Pipe Height: **12** (in.) Rod and Bar (Angled)
Pipe Material: **Clay** ☐ Pipe Lined
Invert Depth: **13.30** (ft.) Flow Characteristics: **Slow**
Deposits: ☒ None ☐ Mud ☐ Sludge ☐ Debris ☐ Grease
Silt Depth: **0** (in.) Deposits Extent:
Infiltration: **None** Pipe Seal Cond: **Sound**

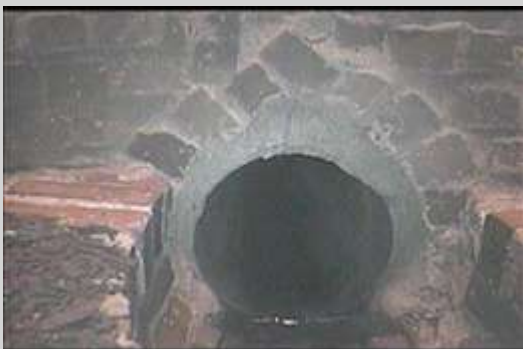
9 O'Clock Inflow

12 in. Circular Gravity Sewer
Pipe In @ 9 O'Clock

Pipe Height: **12** (in.) Rod and Bar (Angled)
Pipe Material: **Clay** ☐ Pipe Lined
Invert Depth: **12.80** (ft.) Flow Characteristics: **Slow**
Deposits: ☒ None ☐ Mud ☐ Sludge ☐ Debris ☐ Grease
Silt Depth: **0** (in.) Deposits Extent:
Infiltration: **None** Pipe Seal Cond: **Sound**
